Historic Façade Materials Assessment Findings Report
for
1059 Willamette Street
Eugene, Oregon

Assessment conducted by
Shannon Sardell, Balance Architecture
with assistance from
Aaron Jensen from Pioneer Waterproofing
October 2019

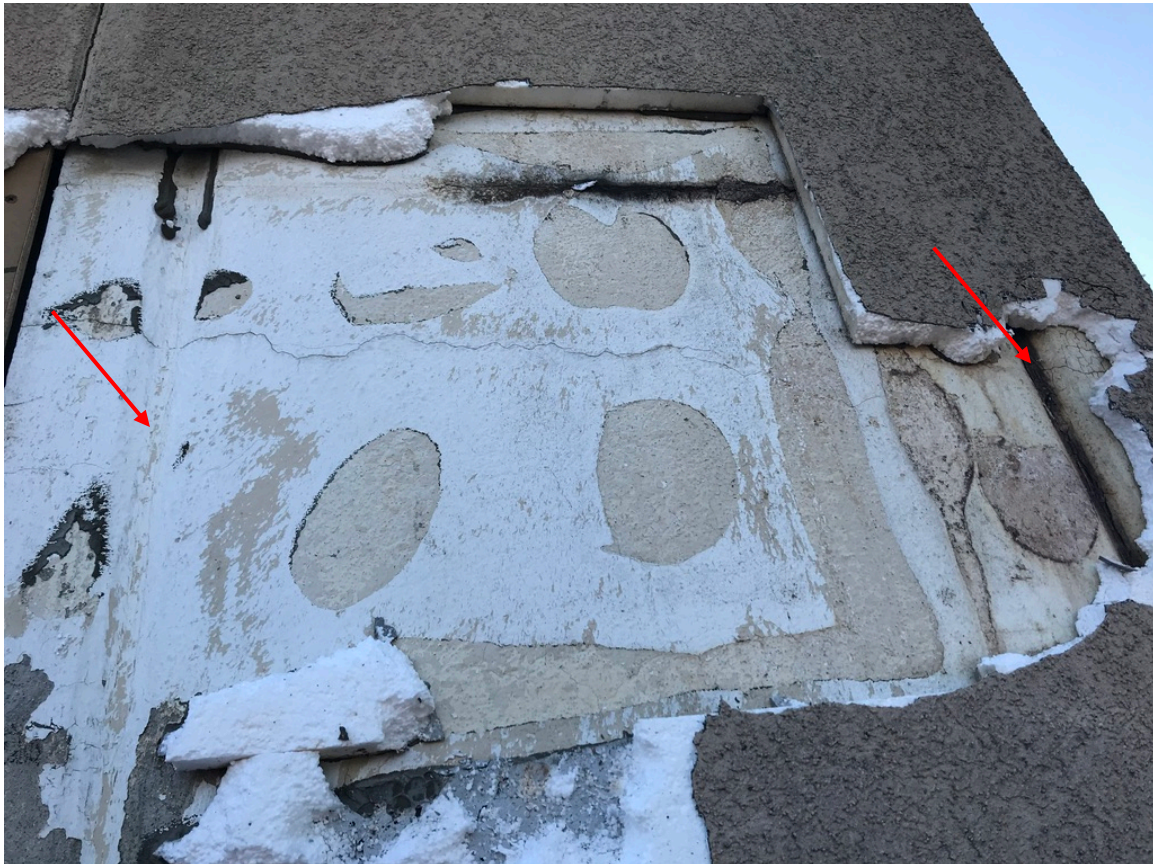
The south corner concrete pier is original to the 1935 photographs and is in good condition. The one observed in this assessment has areas of the original surface treatments and paint color of a buff yellow/cream. There is intact detail where the concrete was scored with vertical grooves about five inches from either edge (Figure 5).

Figure 5 Inspection photo of the current building at 1059 Willamette Street, 2019 south exterior pier facing Willamette Street. The red arrows point to the vertical grooves in the concrete work that are original. Photo credit, author.

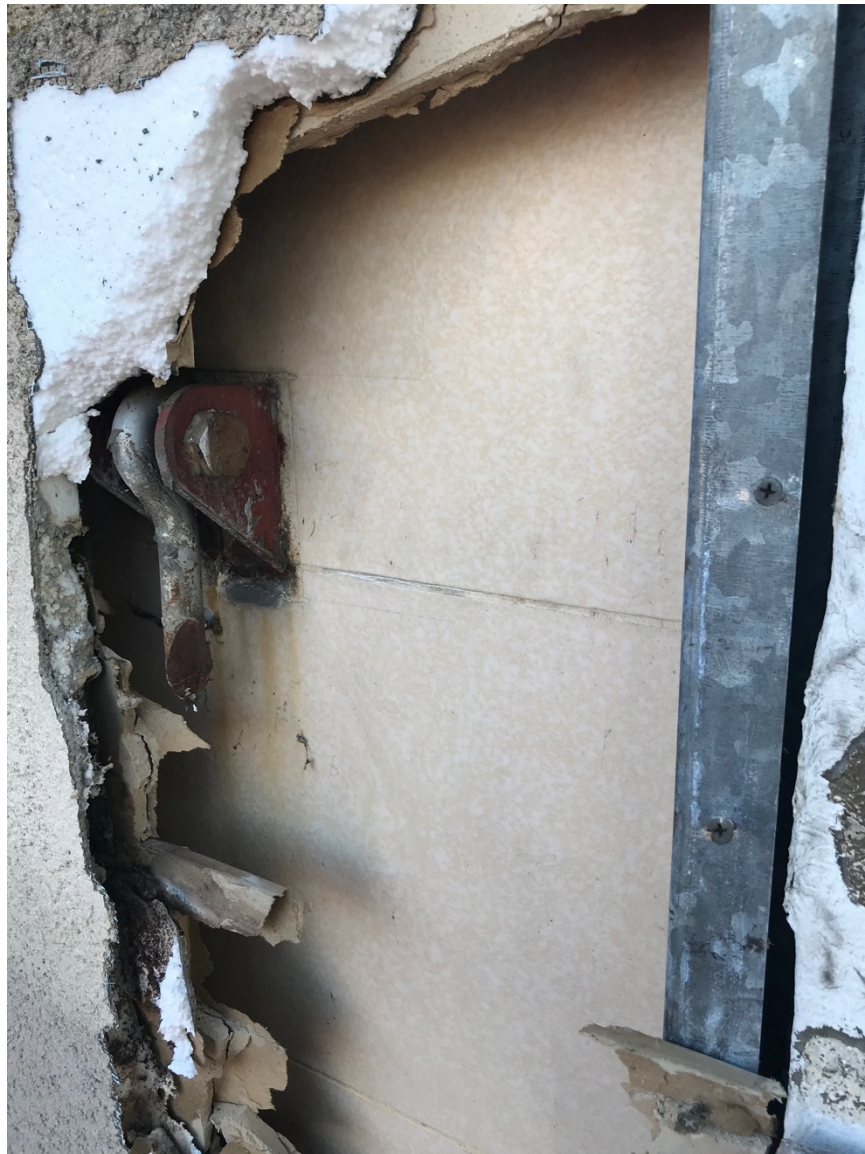
As the exploration towards the center of the sign band and transoms continued, metal studs running vertically were uncovered. They had been screwed into a continuous surface of buff colored, ceramic coated, concrete blocks to allow for a continuous fastening surface for the EFIS material. These studs also created a cavity within which it was observed that the buff

colored concrete blocks extended from the header over the ground floor windows and doors to the upper most reaches of the building. Further metal studs blocked the visual inspection toward the middle of the elevation (Figure 6).

Figure 6 Inspection photo of the current building at 1059 Willamette Street, 2019 with south exterior concrete pier to the far right of photo with steel stud screwed directly into ceramic finished concrete block. Bracket for removed sidewalk awning to the right of the photo. Photo credit, author.

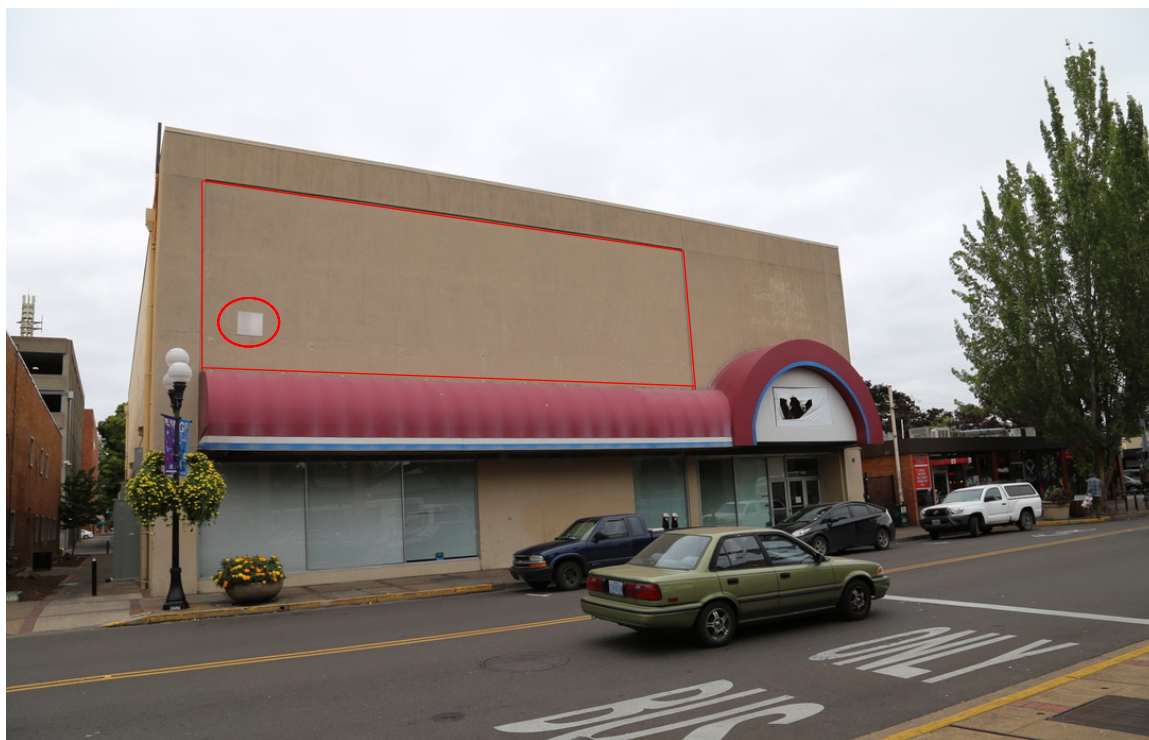
One more attempt at understanding the cladding material in place under the EFIS was undergone at the north side of the elevation where a metal plate had been screwed into the material previously at a location where a material assessment may have been conducted (Figure 7). At this location only some undetermined spray foam material and glue were observed as the mechanism attaching the EFIS to the elevation. There were no other decorative

The condition of the concrete units, concrete mortar and awning brackets behind the EFIS is good where it was inspected along the south side of the Willamette Street elevation. However, there is some concern regarding the condition of the masonry under the inset EFIS panel. During inspection, the metal cover plate within the inset panel was pulled back only to find a spray foam like material behind it. No testing was done to further understand the ease with which the foam and glue used in the surface attachment of the EFIS could be removed from the ceramic face of the 1960's cladding materials. The cladding surface is smooth which could aid with removal because the foam and glue would not be able to permeate the materials pores, but this finish might be easier to scratch.

Figure 7 Inspection photo of the current building at 1059 Willamette Street, 2019 with metal cover plate circled in red and the EFIS inset panel outlined by read rectangle. Photo credit, author.

Also of consideration in the preservation of the 1960's remodeled elevation, are a number of holes in masonry units where screws have been used to affix the metal stud braces for the support of the current EFIS cladding material. It is likely that the screw holes would only be found in the areas around the edges of the elevation outside the inset panel (Figure 7).

Holes created from the screws attaching the metal stud framing for the EFIS would need to be filled with a color and finish appropriate masonry filler. Again, mockups and testing are highly recommended to get the closest match and longest lasting applications. Generally, the mortar joints are in good condition. They should be inspected but it is assumed that repointing would not be necessary as part of this restoration.

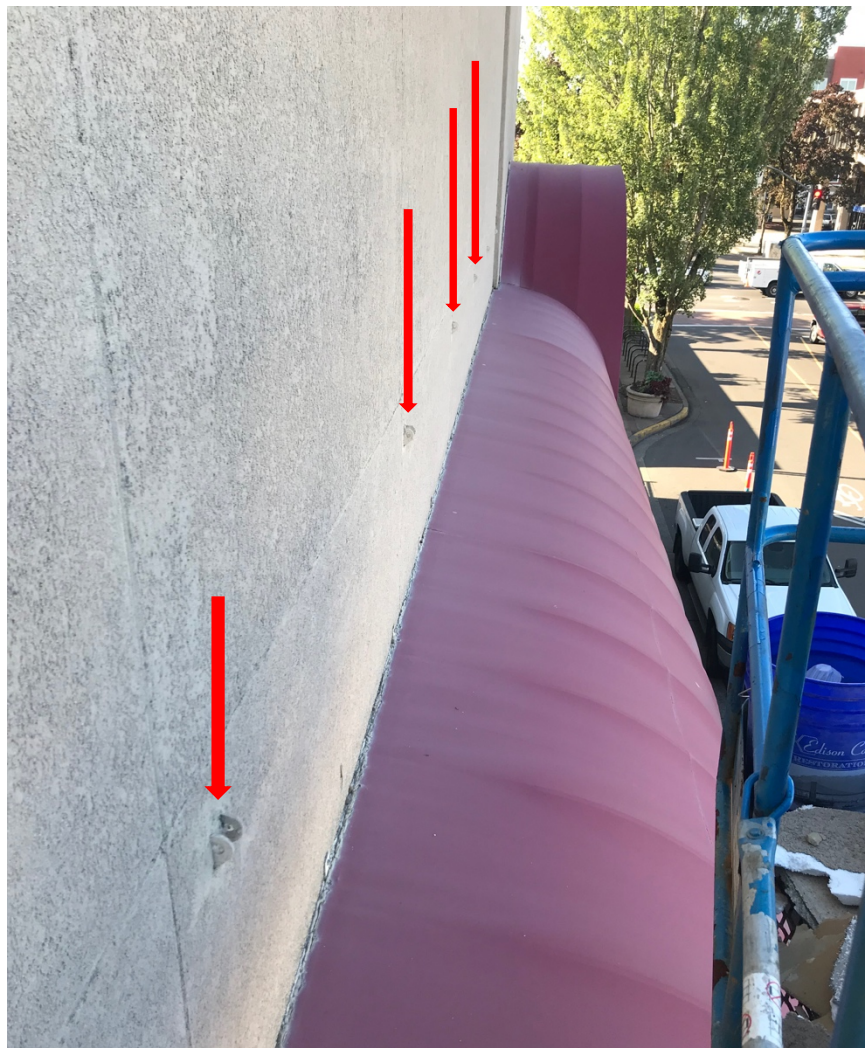
Because the awning brackets from the 1960's addition were left in place, restoration of the awning is possible. There is only minimal rust staining below the awning bracket that was revealed during the inspection. The other brackets for the suspended awning are partially exposed through the current EFIS material and have experienced continual exposure. Further inspection is needed to ensure safety of a suspended awning over a public walking space (Figure 8).

Figure 8 Inspection photo of the current building at 1059 Willamette Street, 2019. The red arrows indicate where the awning brackets project through the EFIS finish material. Photo credit, author.

All of the awning brackets need to be evaluated for deterioration and structural integrity with the assistance of a structural engineer. It is assumed that there would be a 50% replacement rate due to their exposure through the EFIS wall cladding (Figure 8). Areas below the brackets where there is rust staining would need to be cleaned with an environmentally friendly cleaner and in the gentlest means possible to avoid scratching the concrete block's ceramic surface of the concrete blocks. Best practices would allow for testing for appropriate before completing the cleaning process. A new awning could be suspended in a similar location to the mid-century Montgomery Ward elevation seen in historic photos from Lane County History Museum (Figure 4).

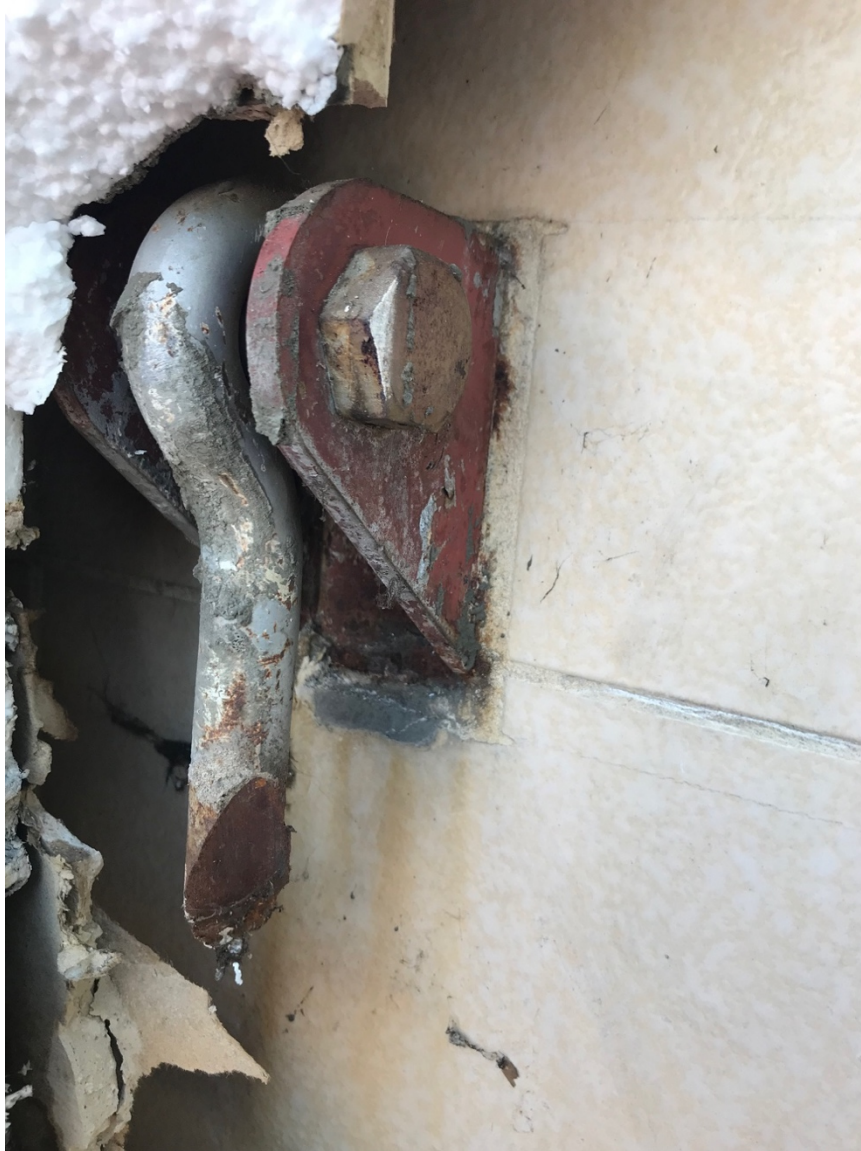
Figure 9 Inspection photo of the current building at 1059 Willamette Street, 2019. This is a detail of the awning bracket condition with minimal rust staining below and good condition of the mortar joint between masonry units. Photo credit, author.
